# VON KARMAN CENTER

SNAP-8 DIVISION

## SNAP-8 MATERIALS REPORT FOR JANUARY-JUNE 1965

REPORT NO. 3038 (SEMIANNUAL) / JULY 1965 / COPY NO. **13**

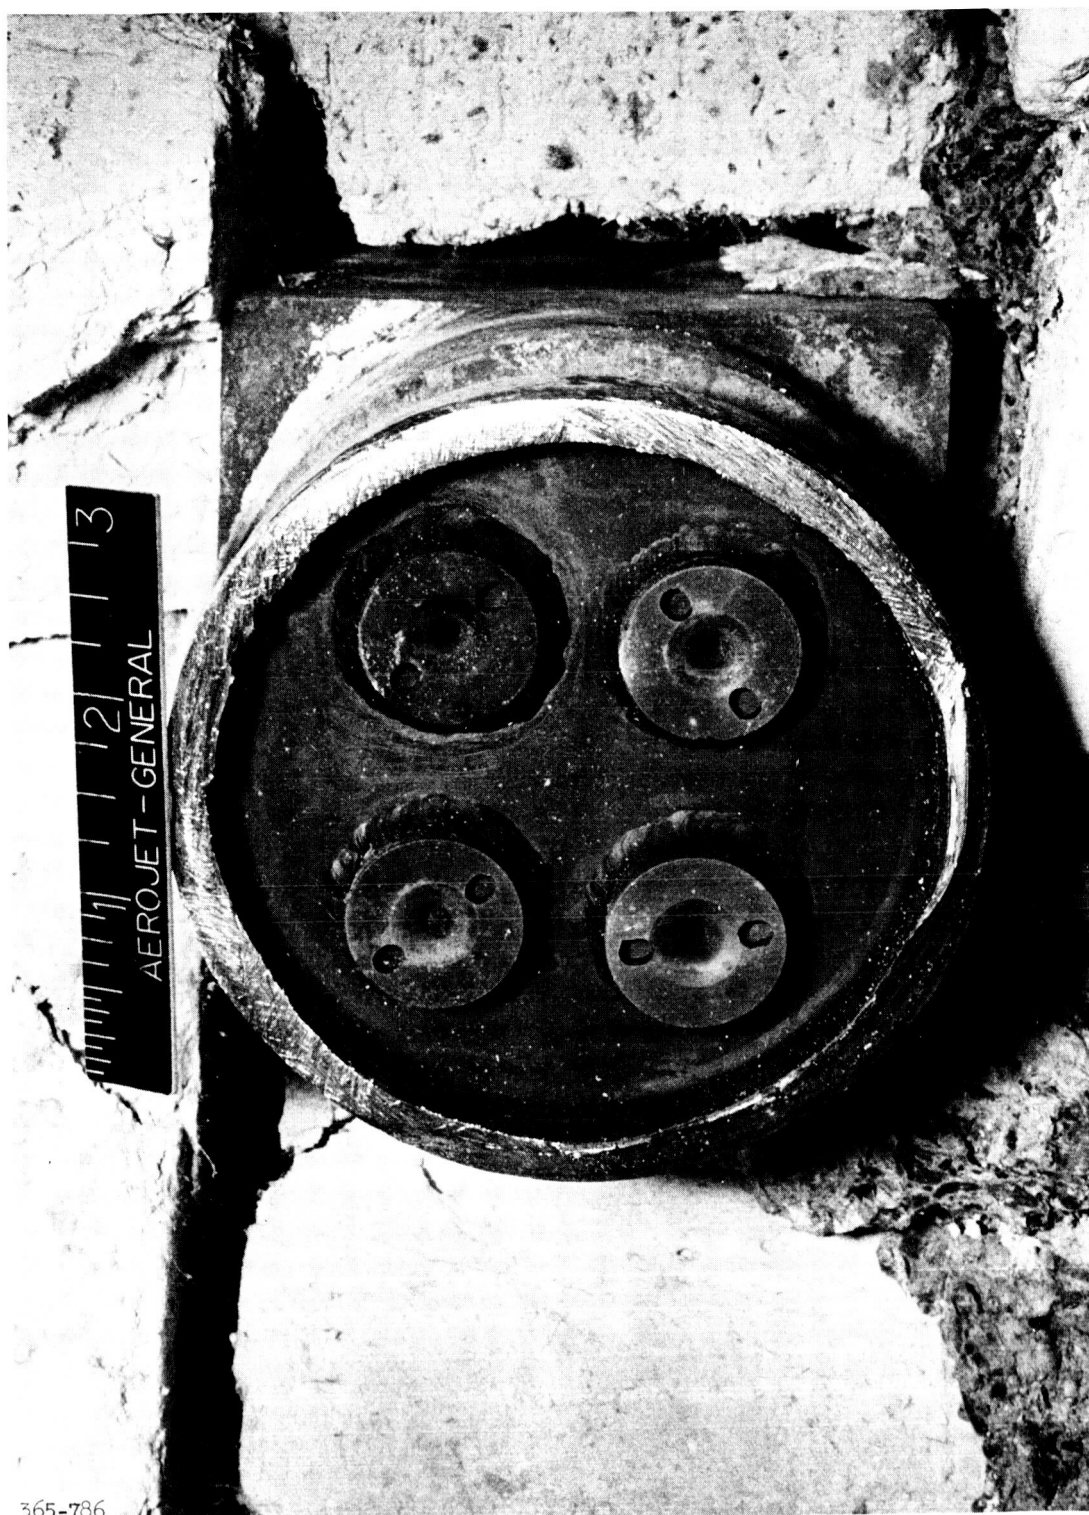
Figure 2

After the March test period, the boiler-inlet manifold was removed. A particle was found lodged in the upper-left tube-inlet-restrictor orifice (see Figure 2). Evaluation indicated that the particle was of mild steel and probably was a machining chip (see Ref. 5, p. IV-3). Potential loop sources for this chip are the turbine-simulator lines and some mild-steel parts of the boiler.

SNAP-8 -1 Boiler, Mercury-Inlet Manifold Showing Blocked Inlet Restrictor (Upper Left)

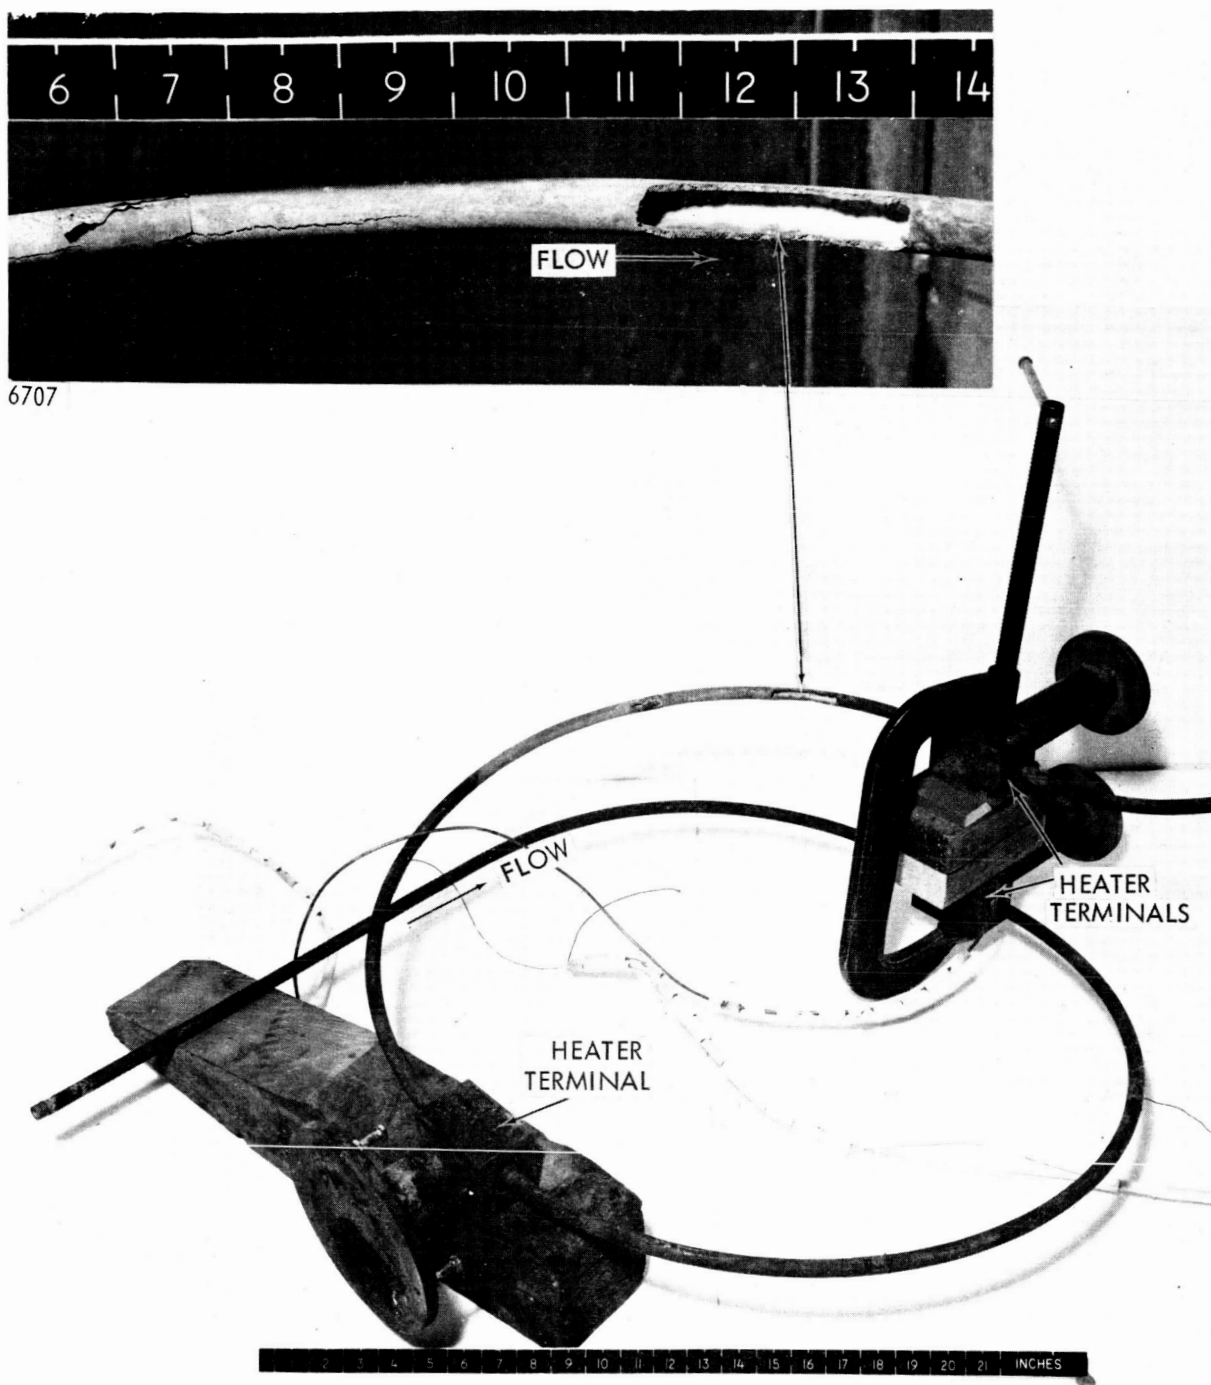
Corrosion Loop 3 (CL-3) was removed from its test cells and disassembled after a section of 316 SS tubing failed in the NaK heater, causing a shutdown. The failure resulted from intergranular cracking associated with a second phase that precipitated heavily at the grain boundaries, especially in the failure area. Selective etching indicated the precipitate may be sigma phase.

NaK-Heater Tube Showing Area of Failure, Corrosion Loop 3 (CL-3)

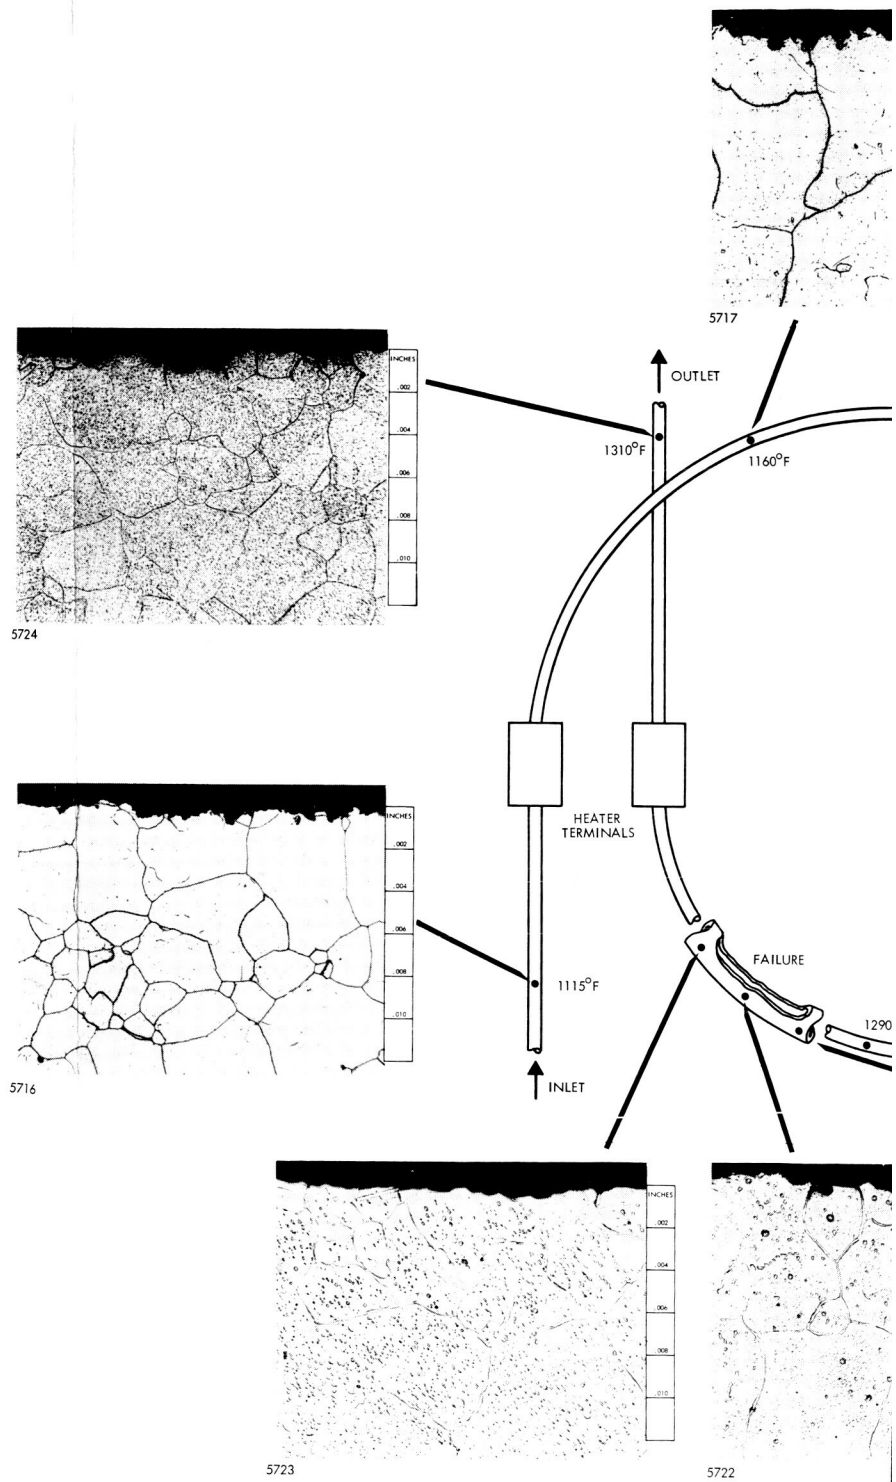
Figure 14

er Tubing, CL-3 (Vilella's Etch)

Microstructure of 316 SS NaK-Heat

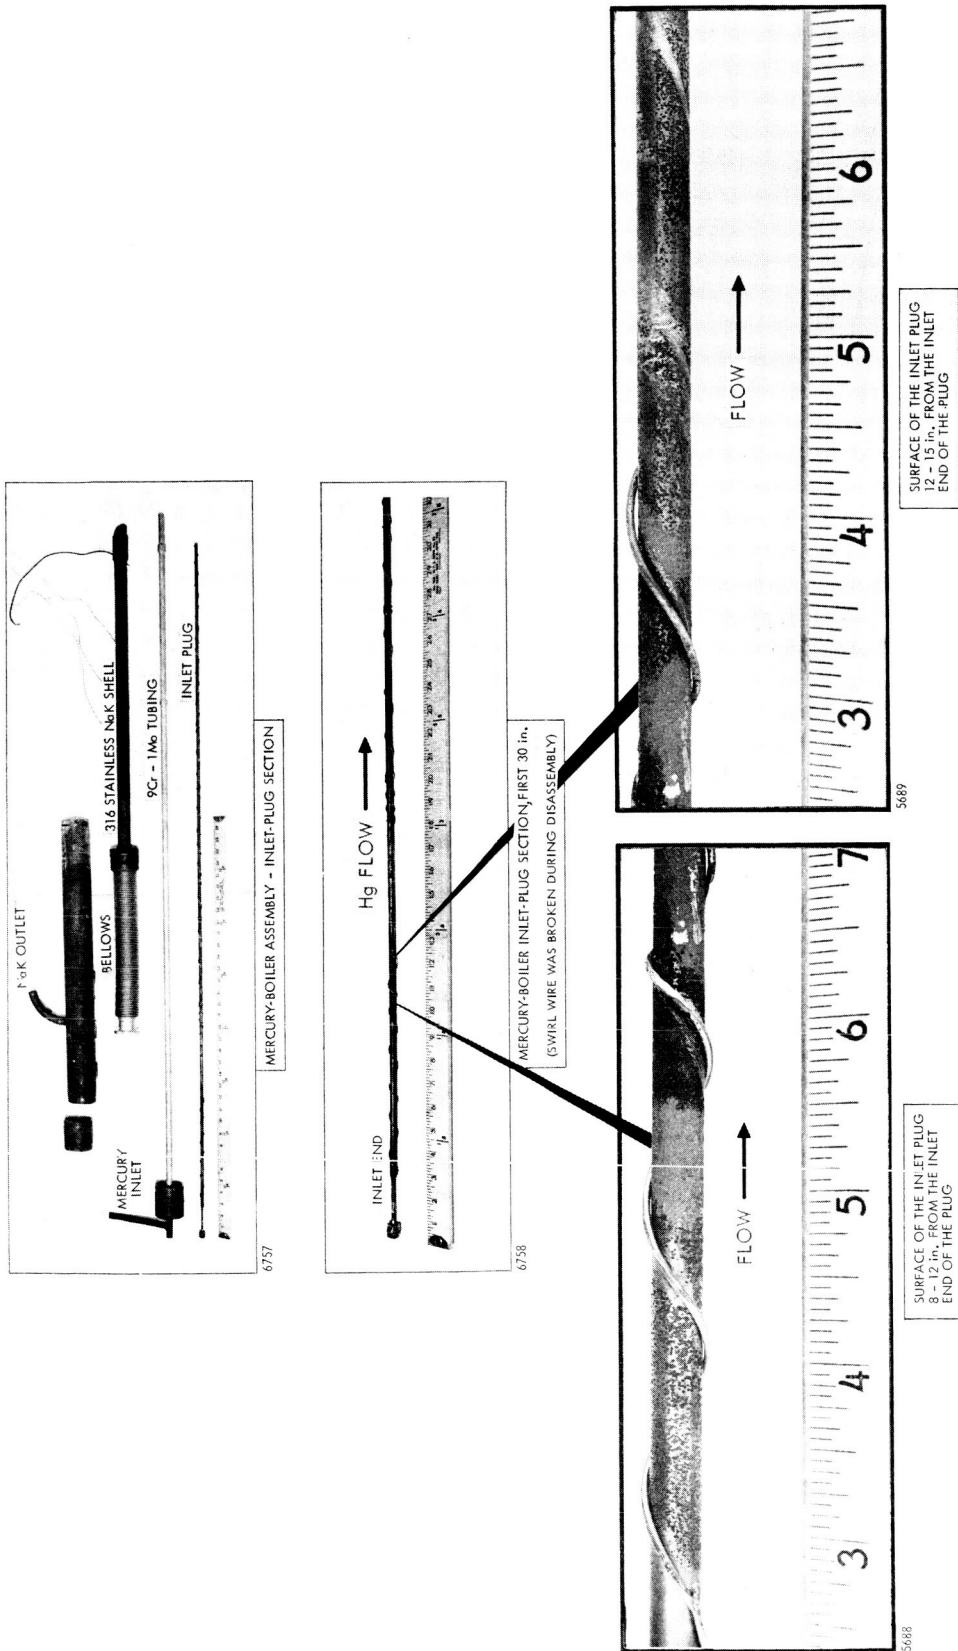
Figure 19

Inlet Plug from CL-3 Boiler

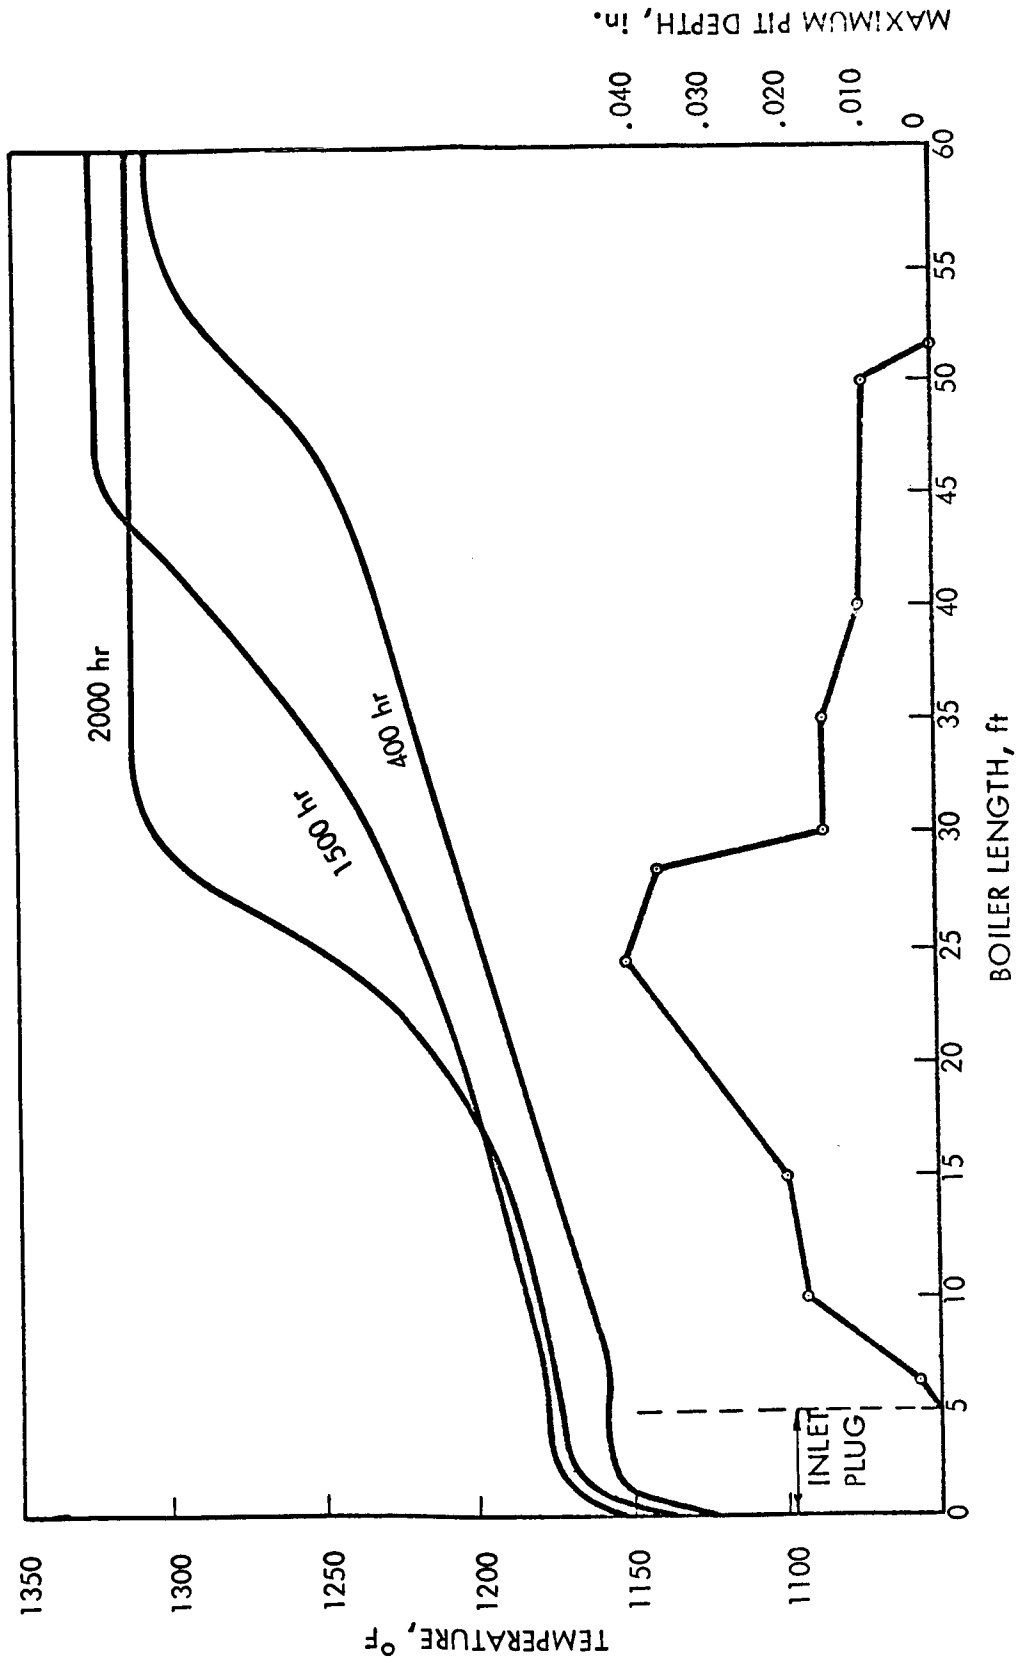
Figure 20

Most of the corrosion-product deposition in the mercury loop was found 25 to 30 ft from the boiler inlet, where the pitting depth increases sharply. The corrosion products are deposited from supersaturated liquid mercury in the liquid vapor stream as the vapor quality approaches 100%.

The change in the NaK-temperature profile with operating time indicates that the mercury-flow pattern was changing constantly up to 2000 hours of operation. This would account for the pitting and corrosion-product deposition observed in the region 30 to 50 ft from the mercury inlet.

Pitting Depths in 9Cr-1Mo Steel Tubing, CL-3 Boiler
